VERIFIED COMPLAINT

Field Inspection Report

Project: Mansir Printing
24 Shawmut Avenue
Holyoke, Massachusetts 01040

RE: Roof Damage-Code provisions
CL#42661

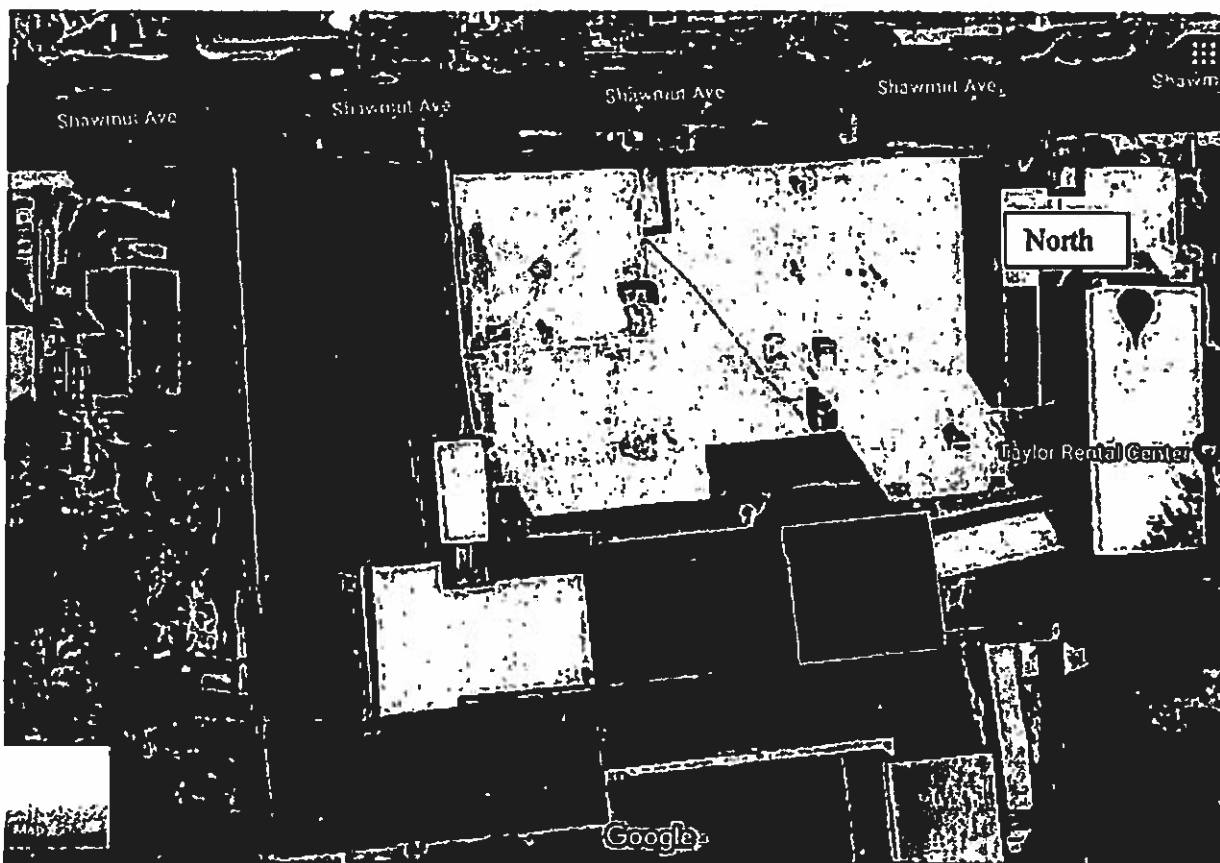
Photo 1. Google Maps ® general approximate overview of the subject property and concerned roof area. Area that is shaded represents approximate proposed repair area.

The damaged section of the roof (noted to be the rear "L" portion of the roof) which is less than approximately 20% of the entire roof area of this level. It is recommended for ease or workmanship and to provide an even seam/joint – that the work area cover the section of roof just past the chimney up to the current existing jog in the roof (as noted Photo 1).

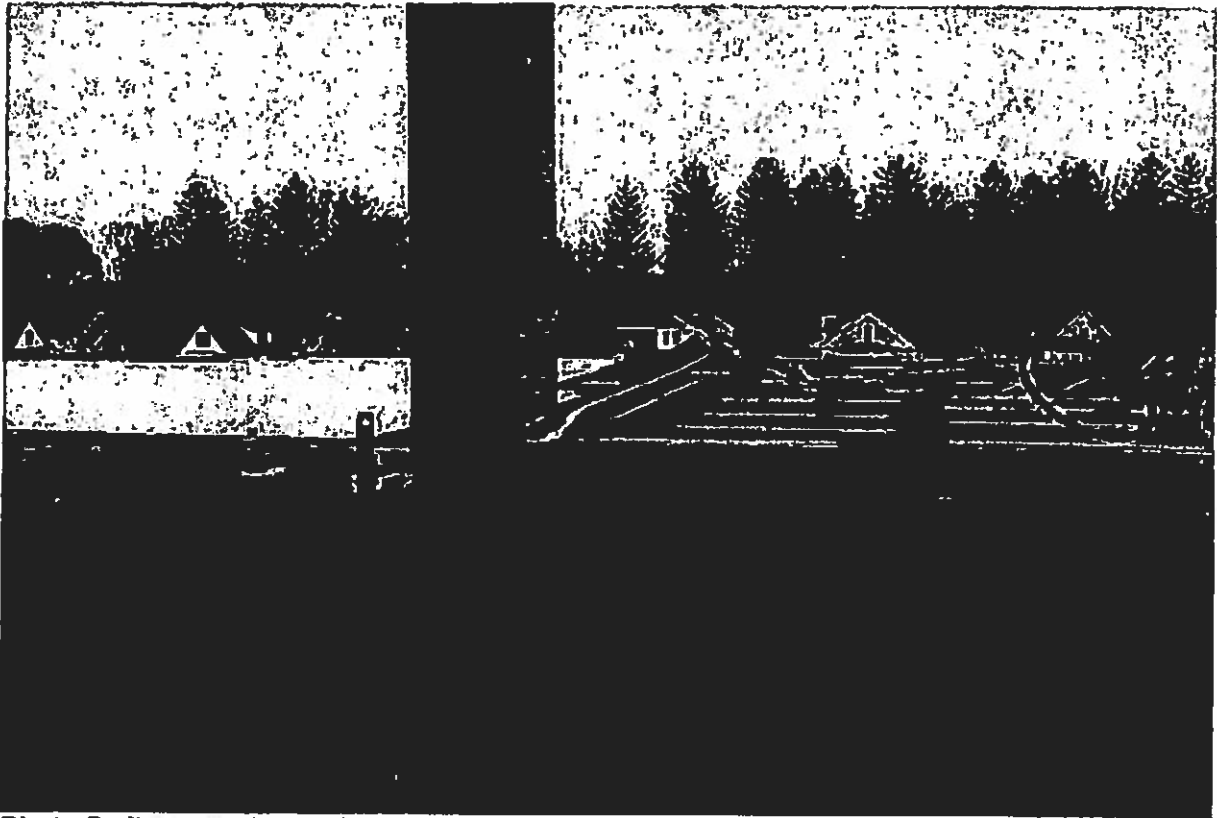
Photo 5. Rear portion of the roof that was tarp, covering up the damaged area along the west wall. Limit of approximate repair noted with line.

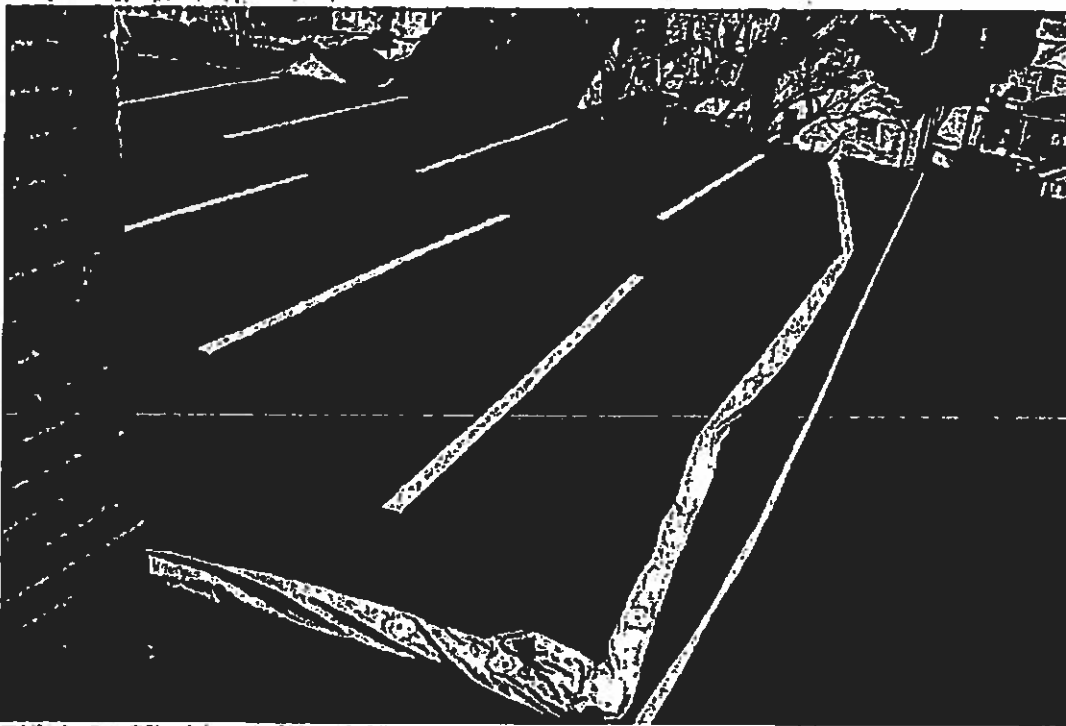
Photo 6. Section along the roof/tarp area where a seam could be installed.

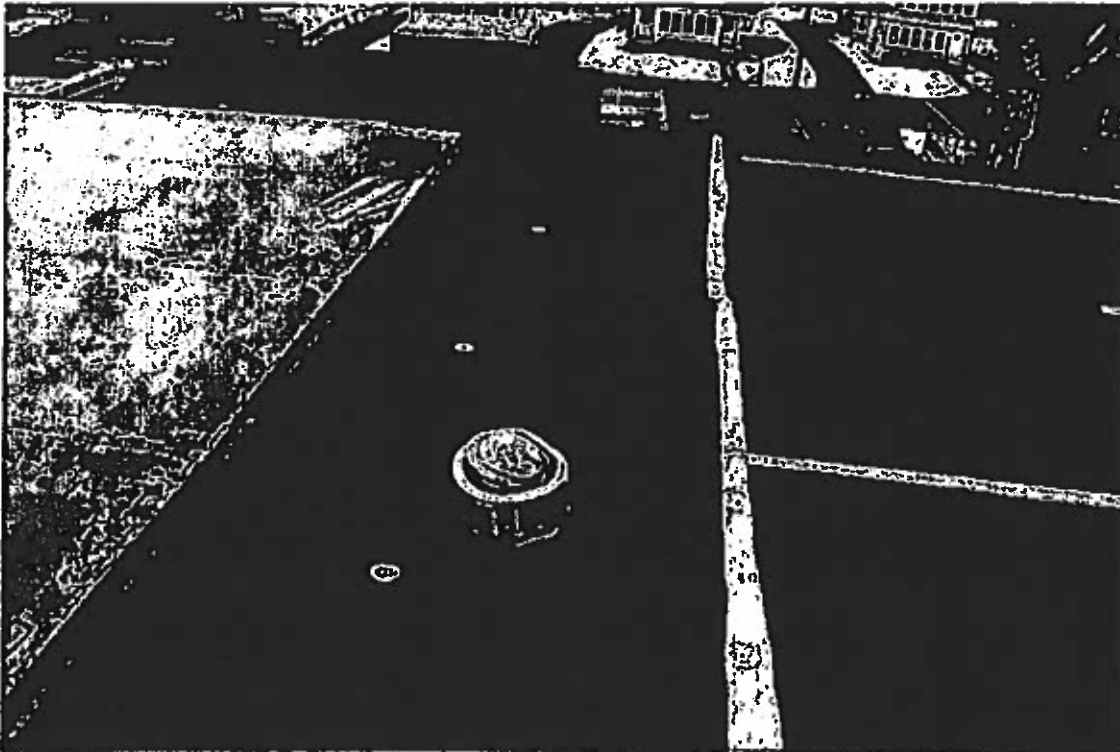
Photo 7. North end of the roof where the edge/termination section is before it drops to another type of roof.

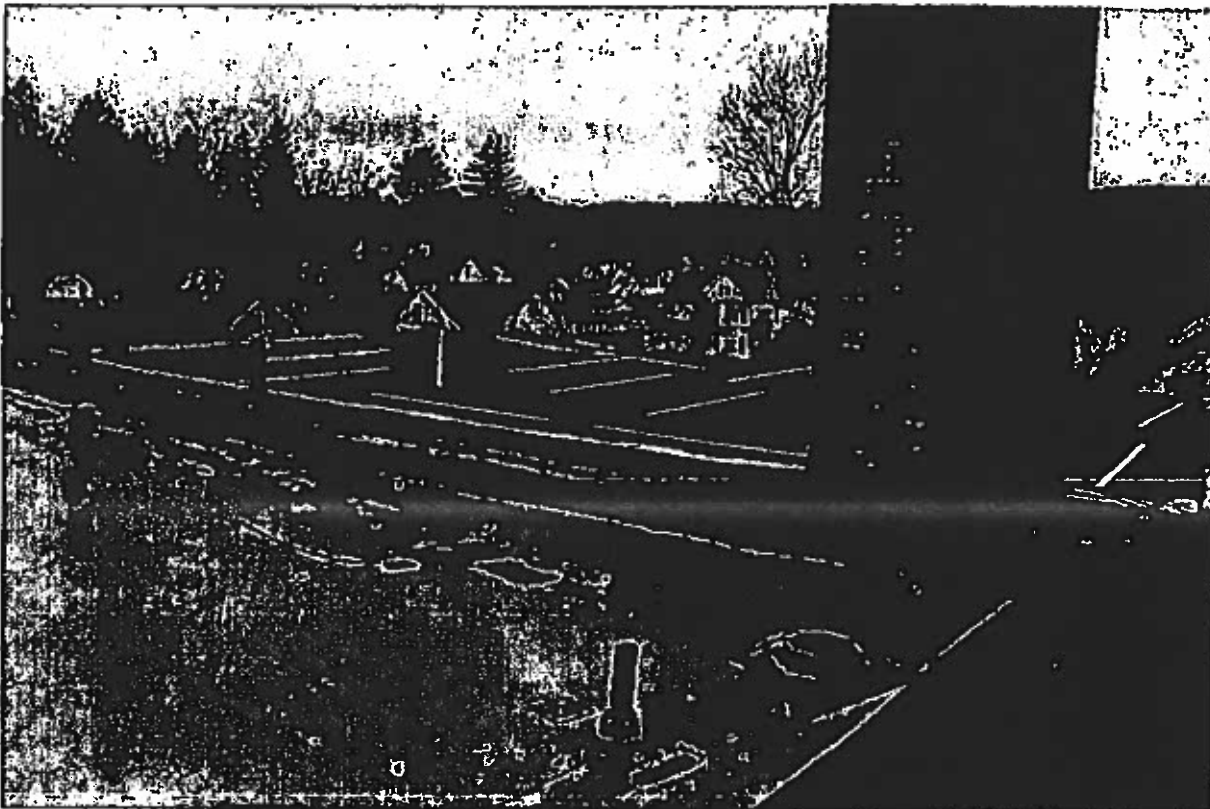
Photo 8. North end of the roof section. Note lower roof level and type *not damaged.

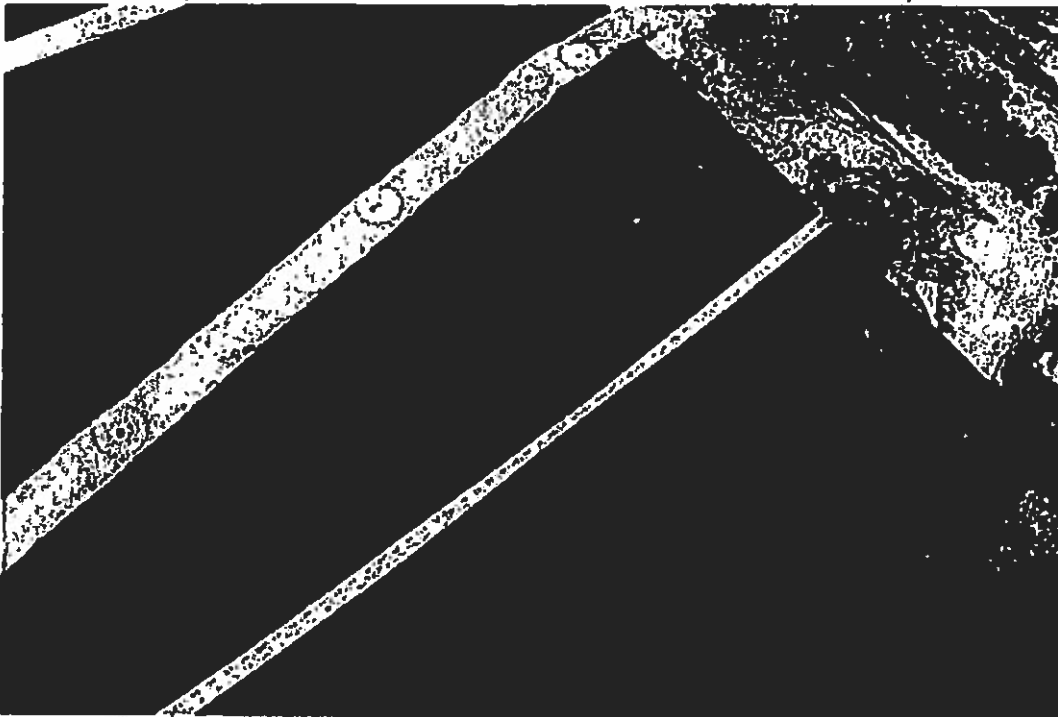
Photo 9. Roof membrane installed in 36" panels with approximate 6-8" overlap at seams and perimeter.

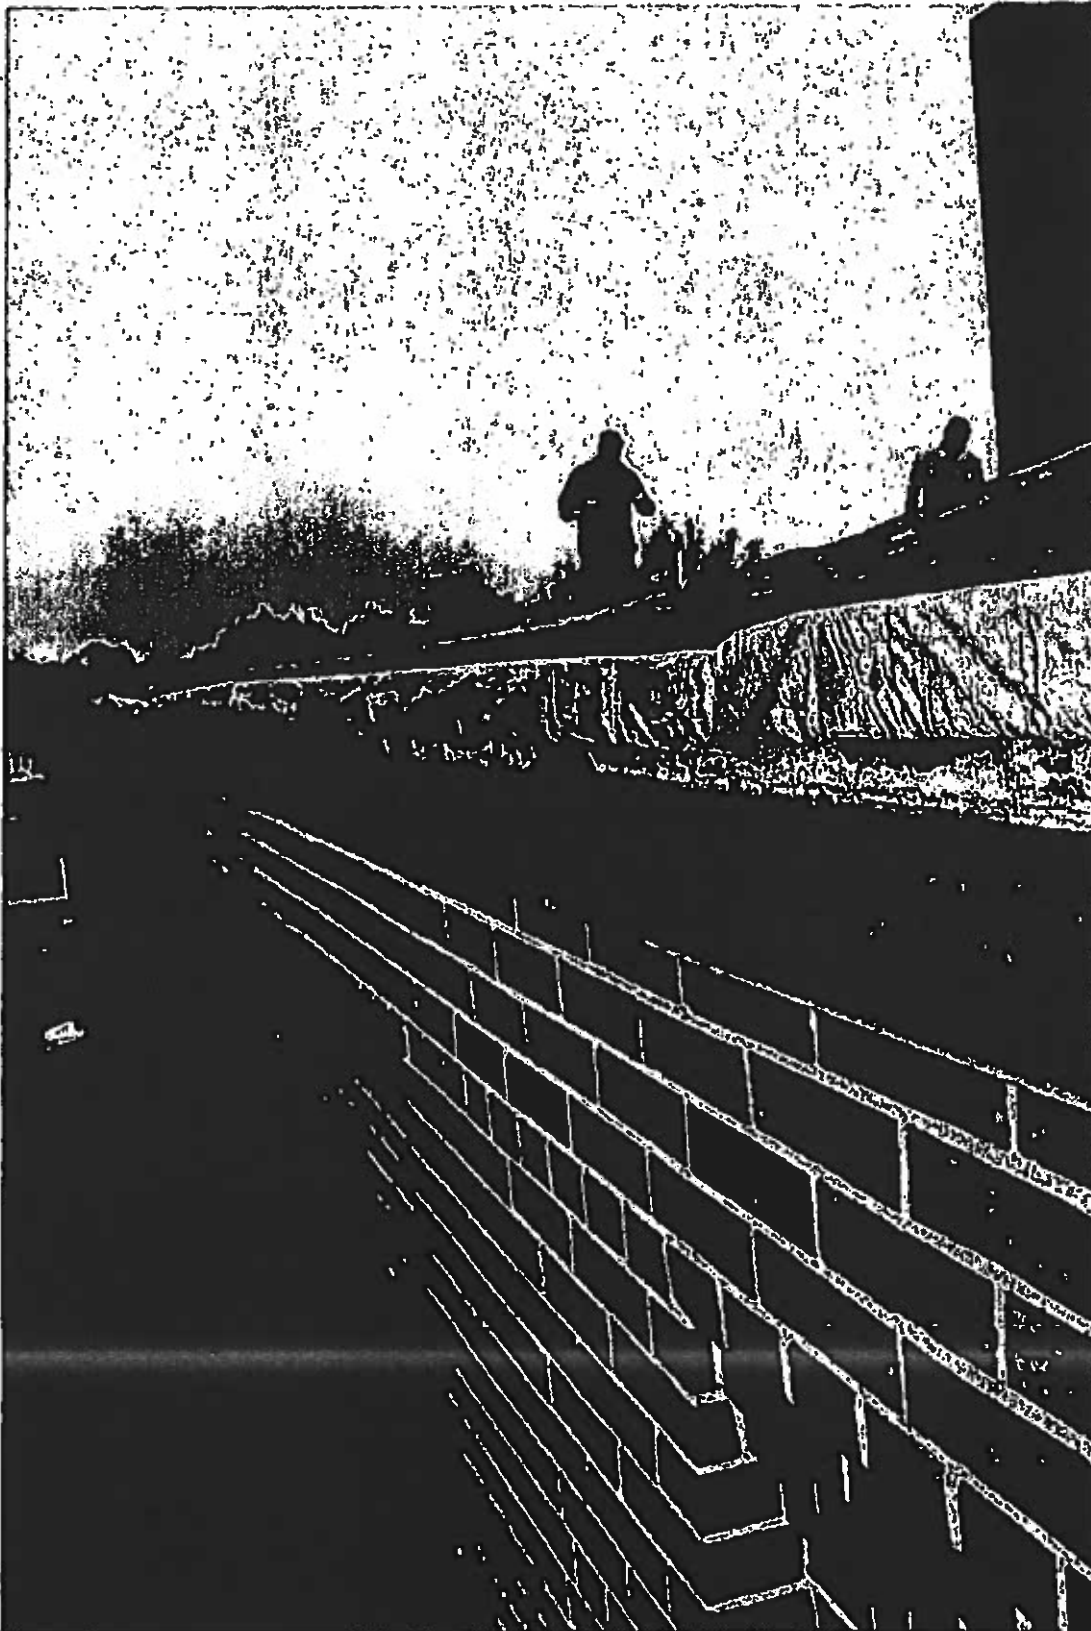
Photo 11. Roof coping/drip edge along the west elevation.

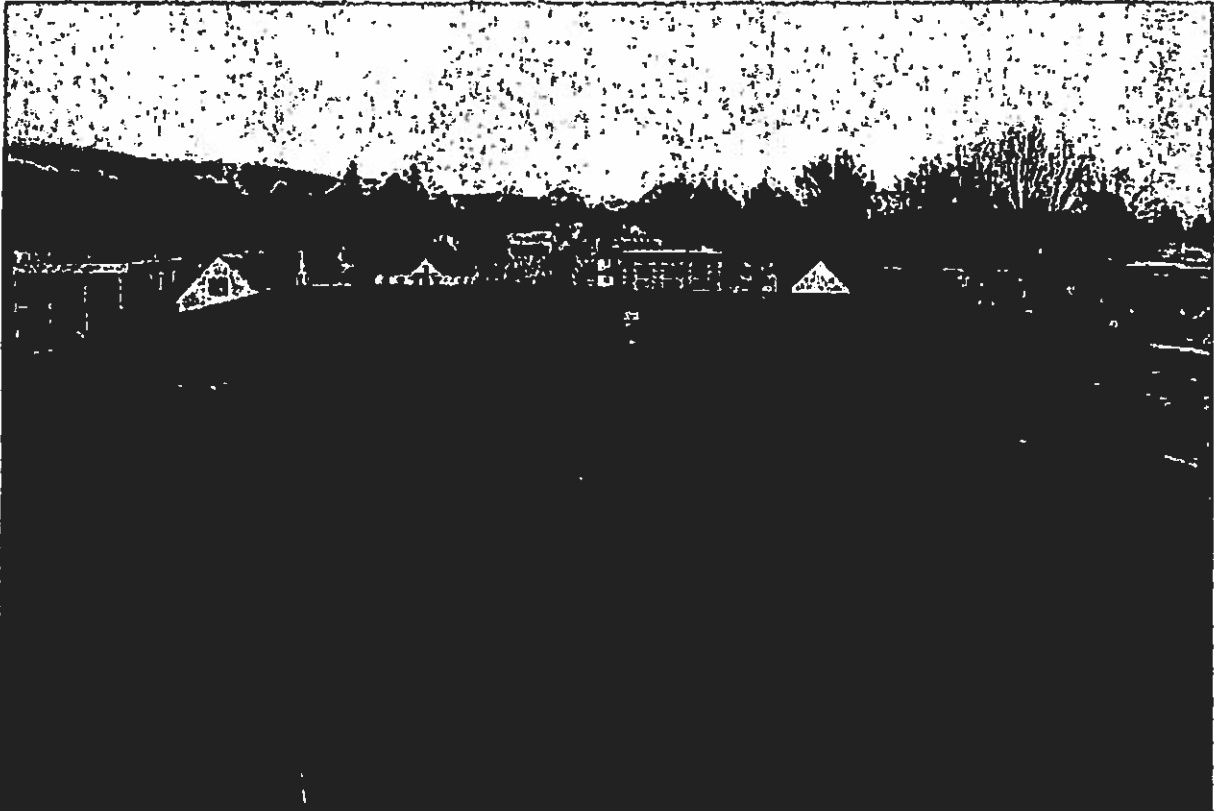
Photo 12. Main remaining area of the existing roof depicting no storm related damage.

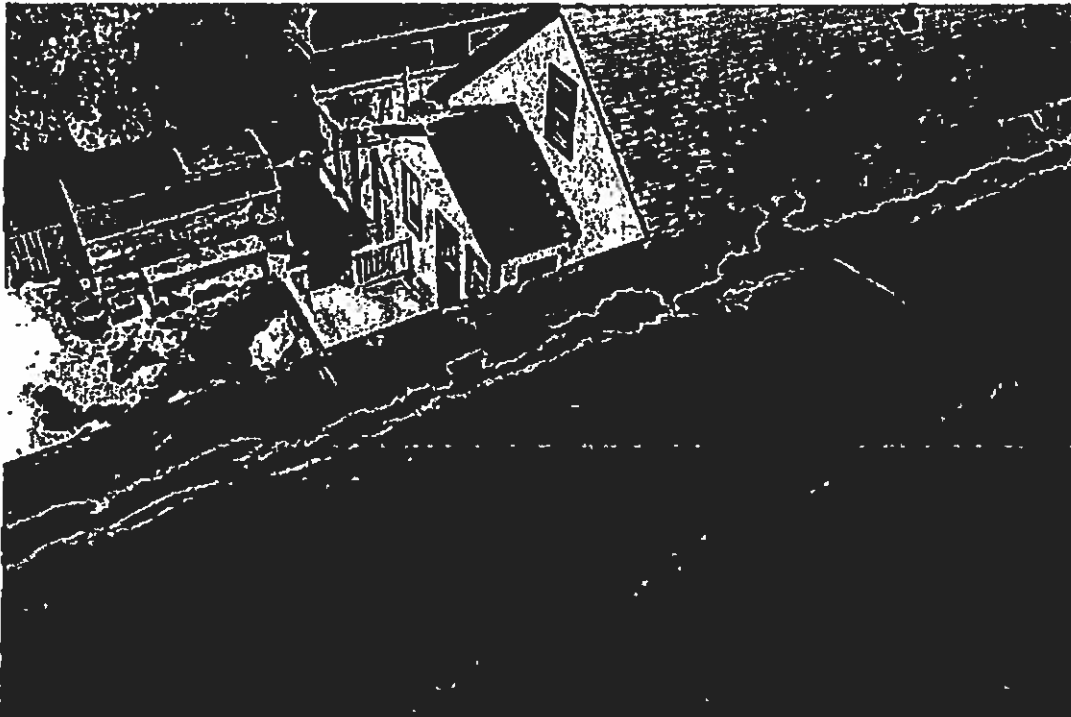
Photo 13. Front edge depicting wear/tear seam cracks along the edging and overlapping coping.

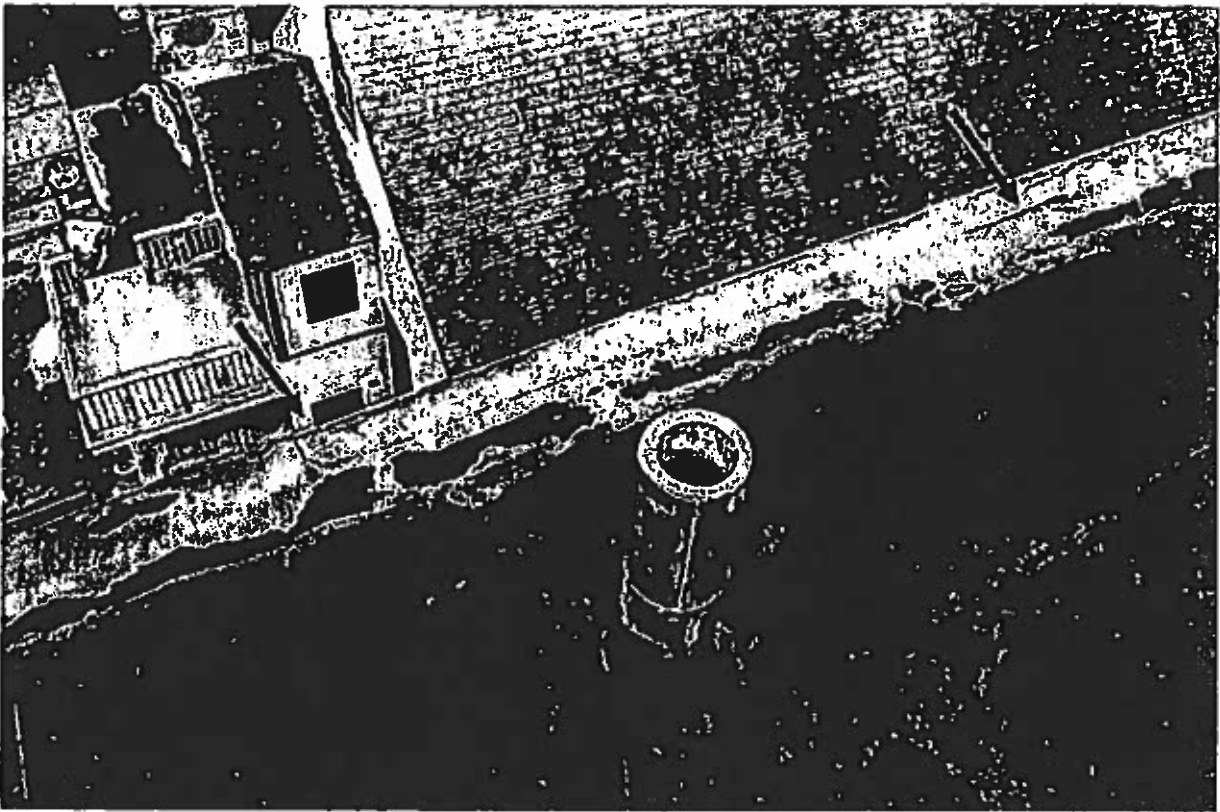
Photo 14. Other area depicting dried out seam crack along the coping/edging and seam crack that is dried out.
